# Salmon Recovery Funding Board Reach-Scale Project Effectiveness Monitoring Program 2018 Final Report

## 2018 Final Report

Phil Roni, Michelle Krall, Chris Clark, and Kai Ross  
Cramer Fish Sciences  
Watershed Sciences Lab  
1125 12<sup>th</sup> Avenue NW, Suite B-1  
Issaquah, WA 98027

**January 7, 2019**

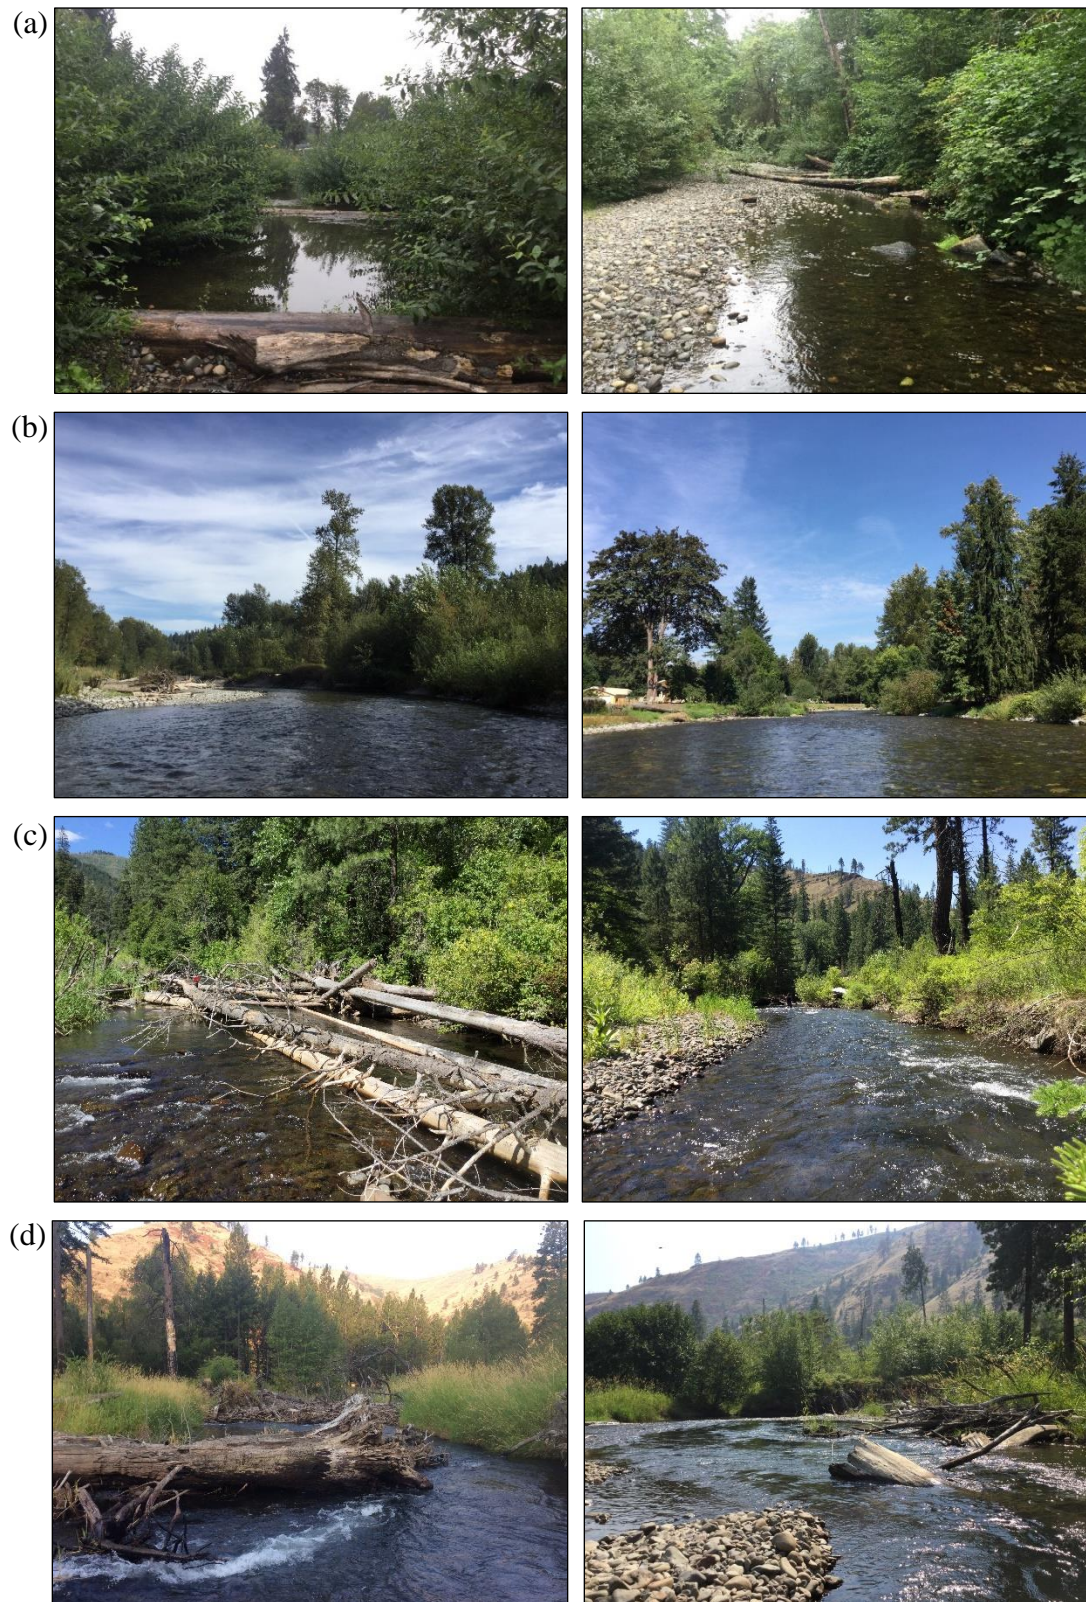
**Figure 2.** Impact (left) and control (right) reaches for (a) 04-1209 Chico Creek, (b) 04-1660 Cedar Rapids, (c) Tucannon PA-3, and (d) Tucannon PA-14.

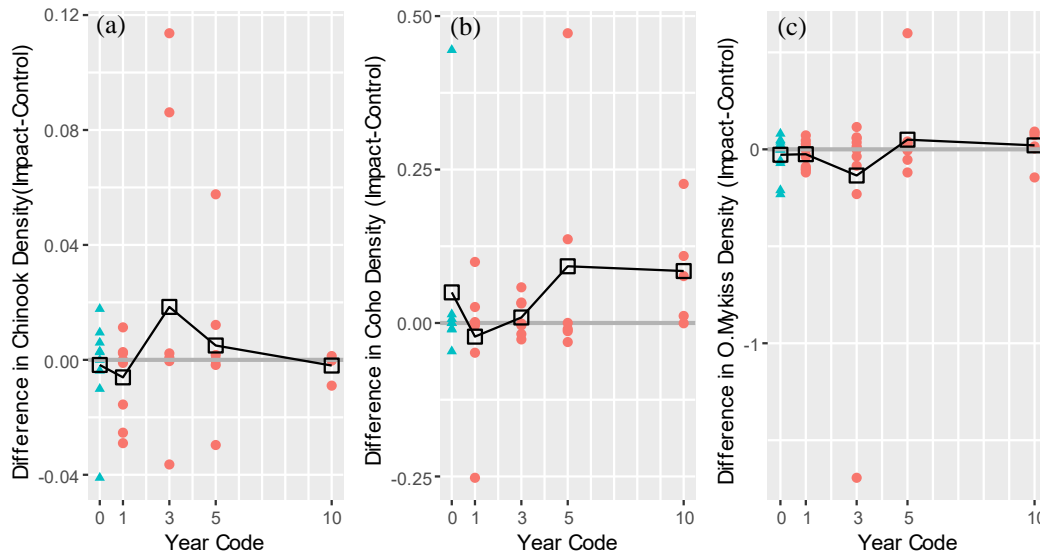
10). Similarly, there were no significant changes in the three fish densities over time using the linear trend analysis (Table 11). Based on the management decision criteria presented in Crawford (2011), by Year 10, instream projects are not meeting management decision success criteria for Chinook salmon, coho salmon, or steelhead densities (Table 12).

**Figure 5.** Mean difference (line and open squares) for densities of Chinook salmon (a), coho salmon (b), and steelhead (c) between the impact and control reaches. The blue triangles and red circles represent before and (Year 0) after monitoring data (Year > 0), respectively.

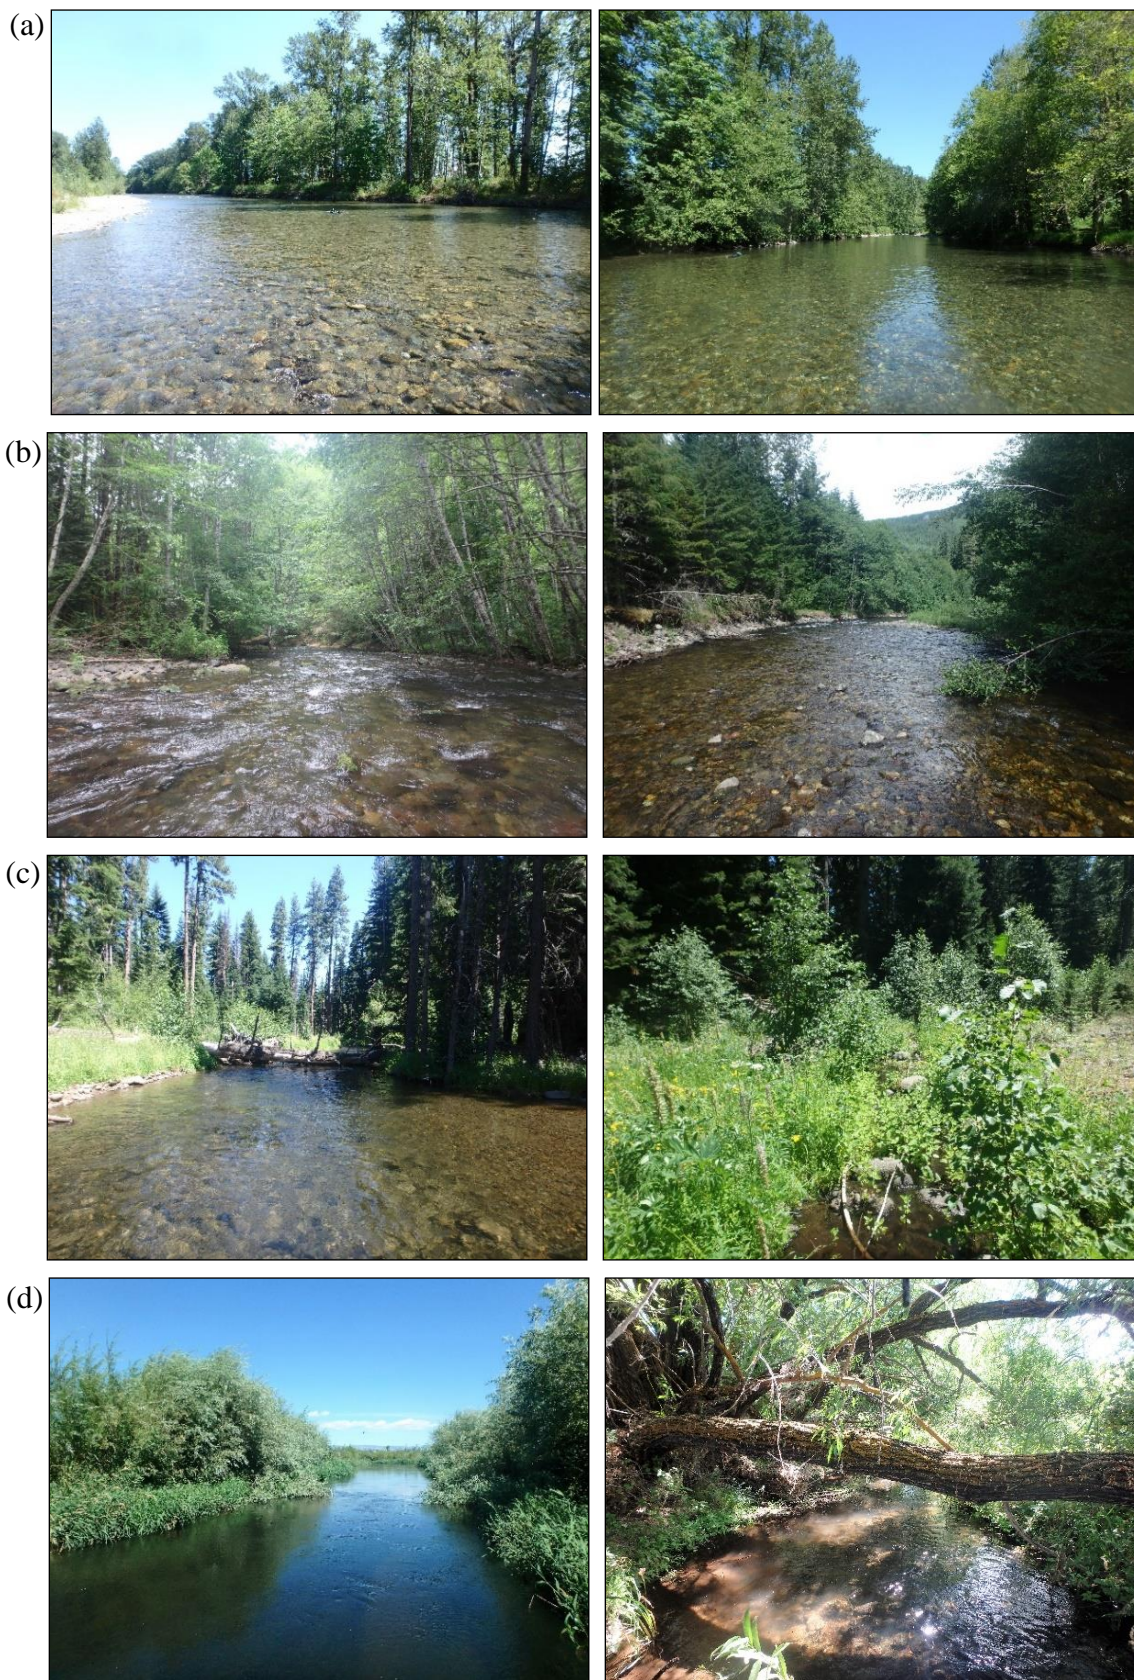
**Figure 14.** Impact (left) and control (right) reaches for (a) 04-1596 Lower Tolt, (b) 06-2223 Greenwater River, (c) 06-2277 Upper Klickitat, and (d) 07-1519 Reecer Creek.

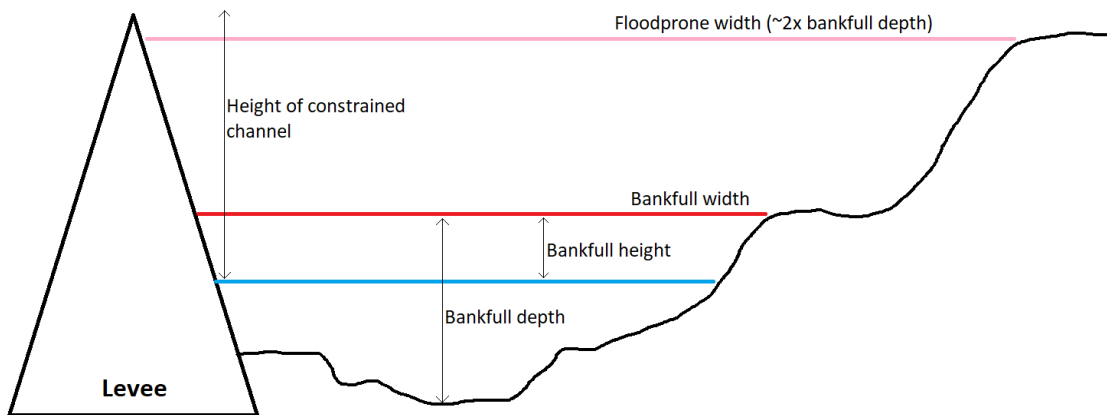
The percent of the channel margin in contact with constraining features was estimated and the height of the constraining feature measured as the vertical distance from the wetted edge to the top of the constraining feature (Figure 16). At Transects A, F, and K, bankfull depth, bankfull height, and the floodprone width were measured. Bankfull width was also measured at each of the 21 transects (11 primary, 10 intermediate) and the entire valley width was measured. Channel constraint measurements were then used to calculate average channel capacity in the reach (Crawford 2011).

**Figure 16.** Channel survey measurements for channel constraints as adopted from Crawford (2011).

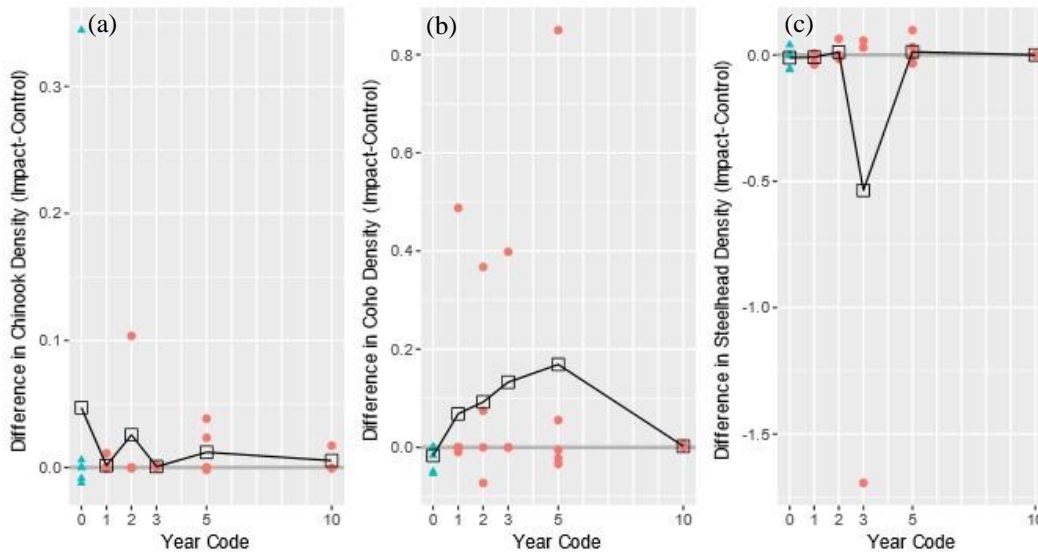
examined densities in fish per linear meter (fish/m) and found similar results with no significant increases for Chinook or steelhead ( $P > 0.10$ ), and a significant increase for coho in Year 1 and Year 5 ( $P < 0.06$ ).

**Figure 20.** Mean difference (line and open squares) for densities of Chinook salmon (a), coho salmon (b), and steelhead (c) between the control and impact reaches for floodplain enhancement projects. The blue triangles represent pre-treatment monitoring data (Year 0) while the red circles represent post-treatment monitoring data (Year > 0).
